Courtesy of BMW OF NORTH AMERICA, INC.
2009 BMW Z4 35i

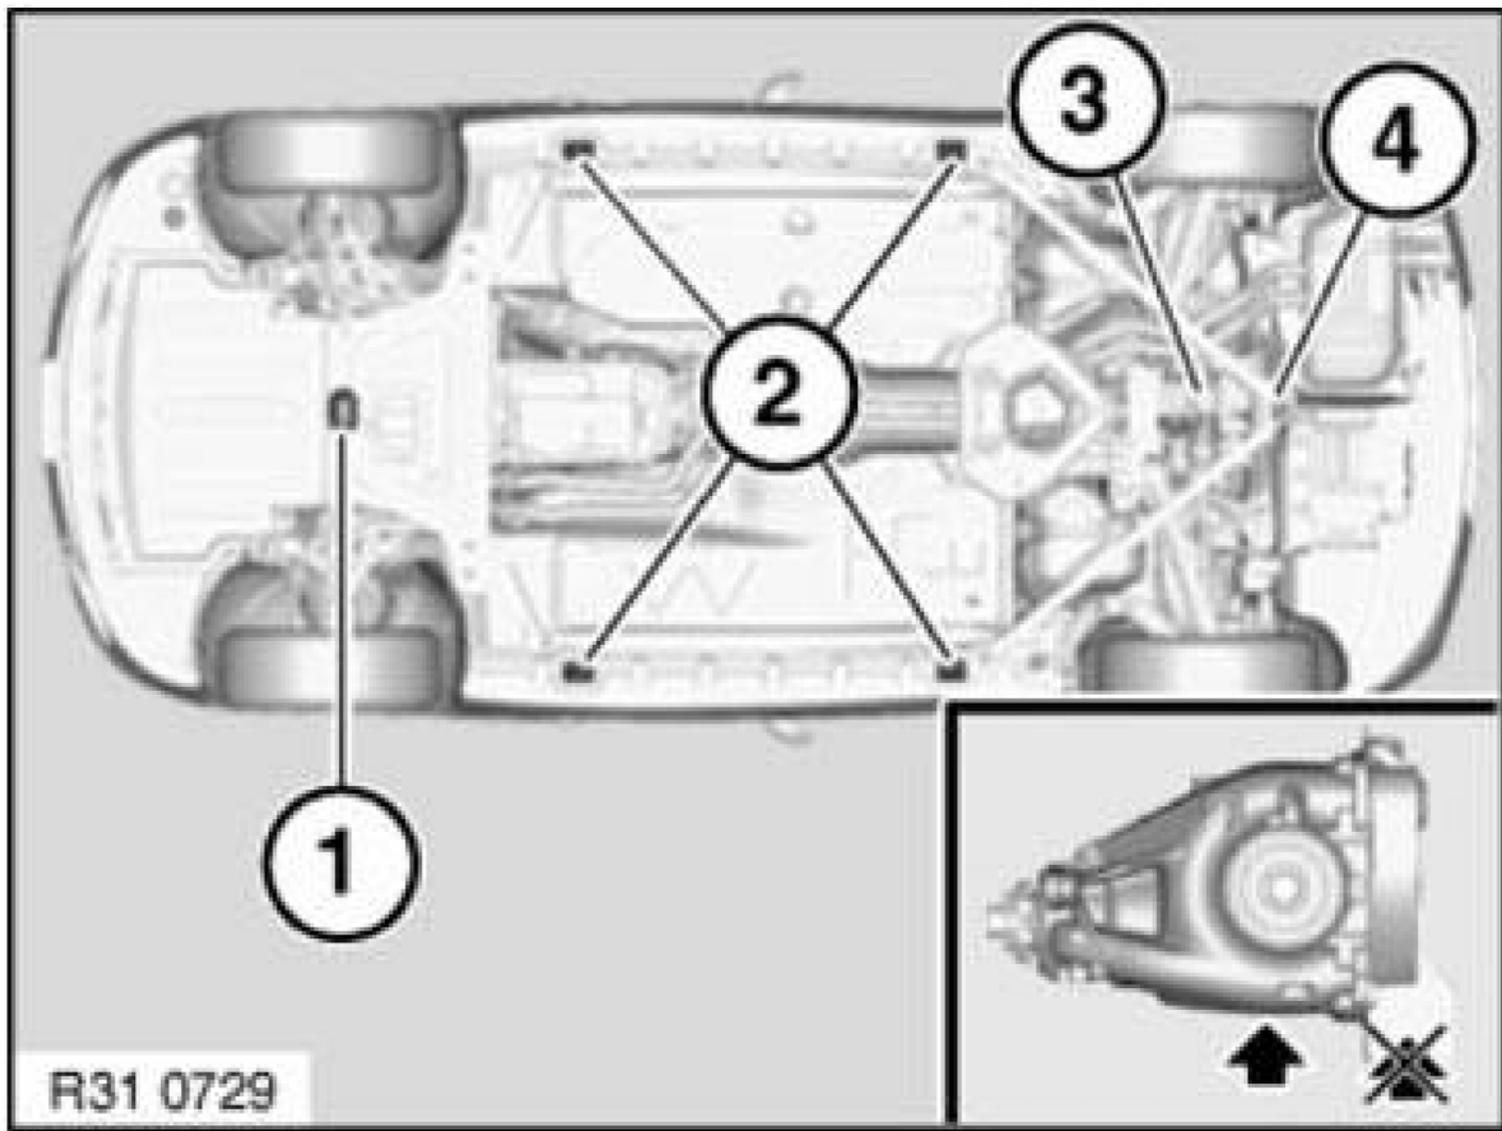
R31 0729

Fig. 16: Identifying Rear Differential With Car Jacking Point
